NORWALK RIVER BASIN
WILTON, CONNECTICUT

SOUTH NORWALK RESERVOIR DAM CT. 00212

PHASE I INSPECTION REPORT NATIONAL DAM INSPECTION PROGRAM

DECEMBER 1978

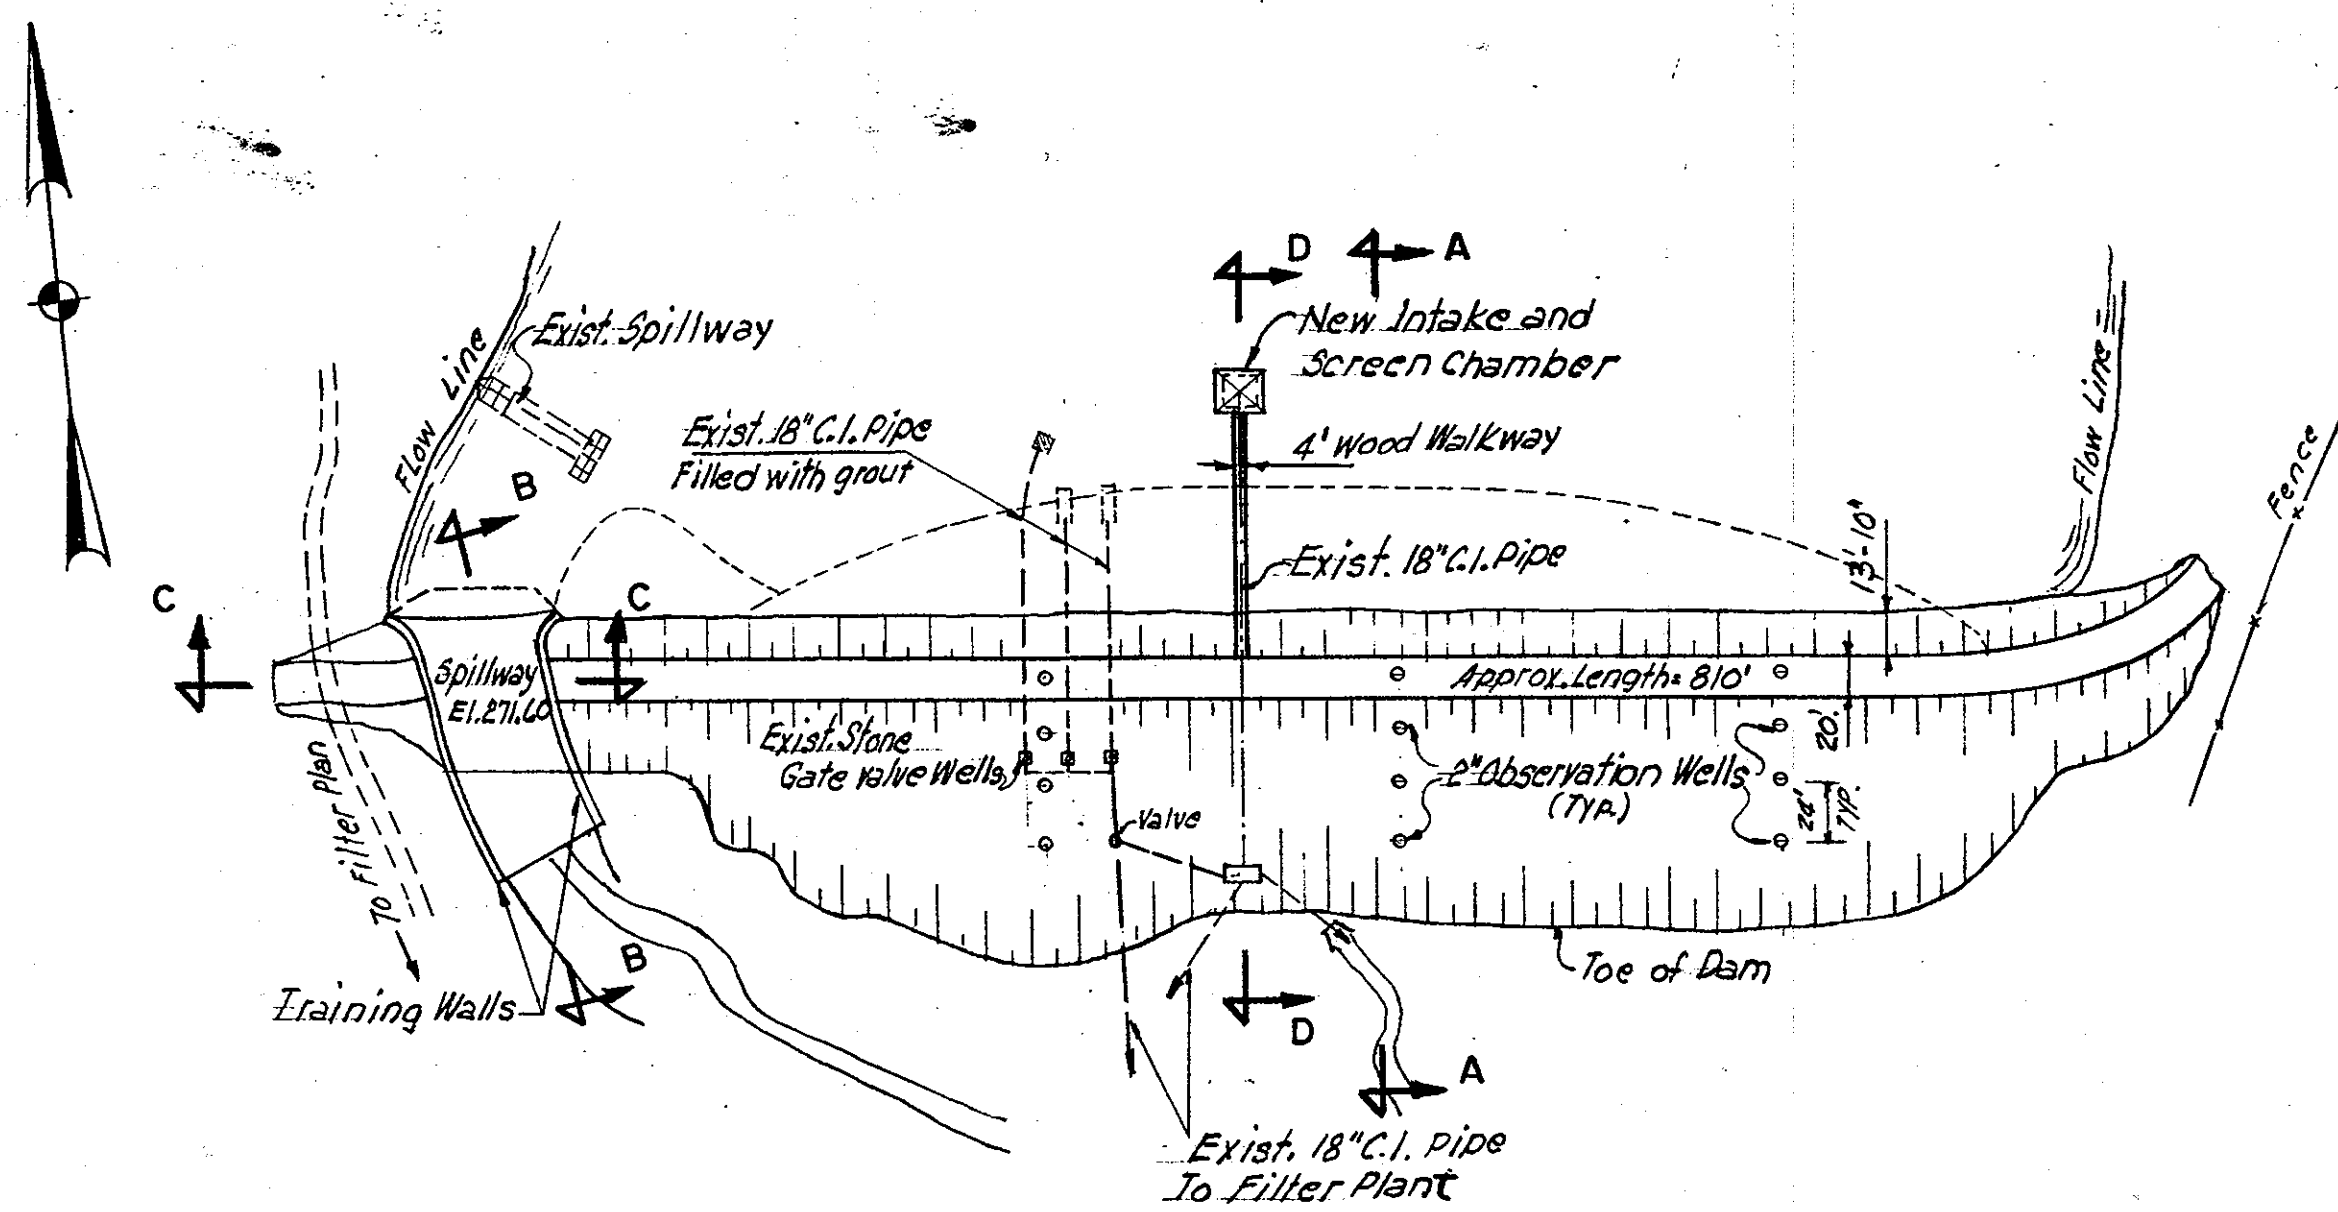
PLATE-1

Before the inspection commenced, the design and construction documents were studied and compact sketches were prepared for use during the inspection (Appendix B, Plates 1 and 2).

drainage rock blanket, an intake and screen chamber and the concrete service spillway (Appendix B, Plates 1 and 2).
